NATIONAL TRANSPORTATION SAFETY BOARD

Video Study

**NTSB Case Number:
CEN17FA127**

Location: Chalmers, Indiana
Date: March 14, 2017
Time: 1546 EDT
Aircraft: MD Helicopters 369FF helicopter

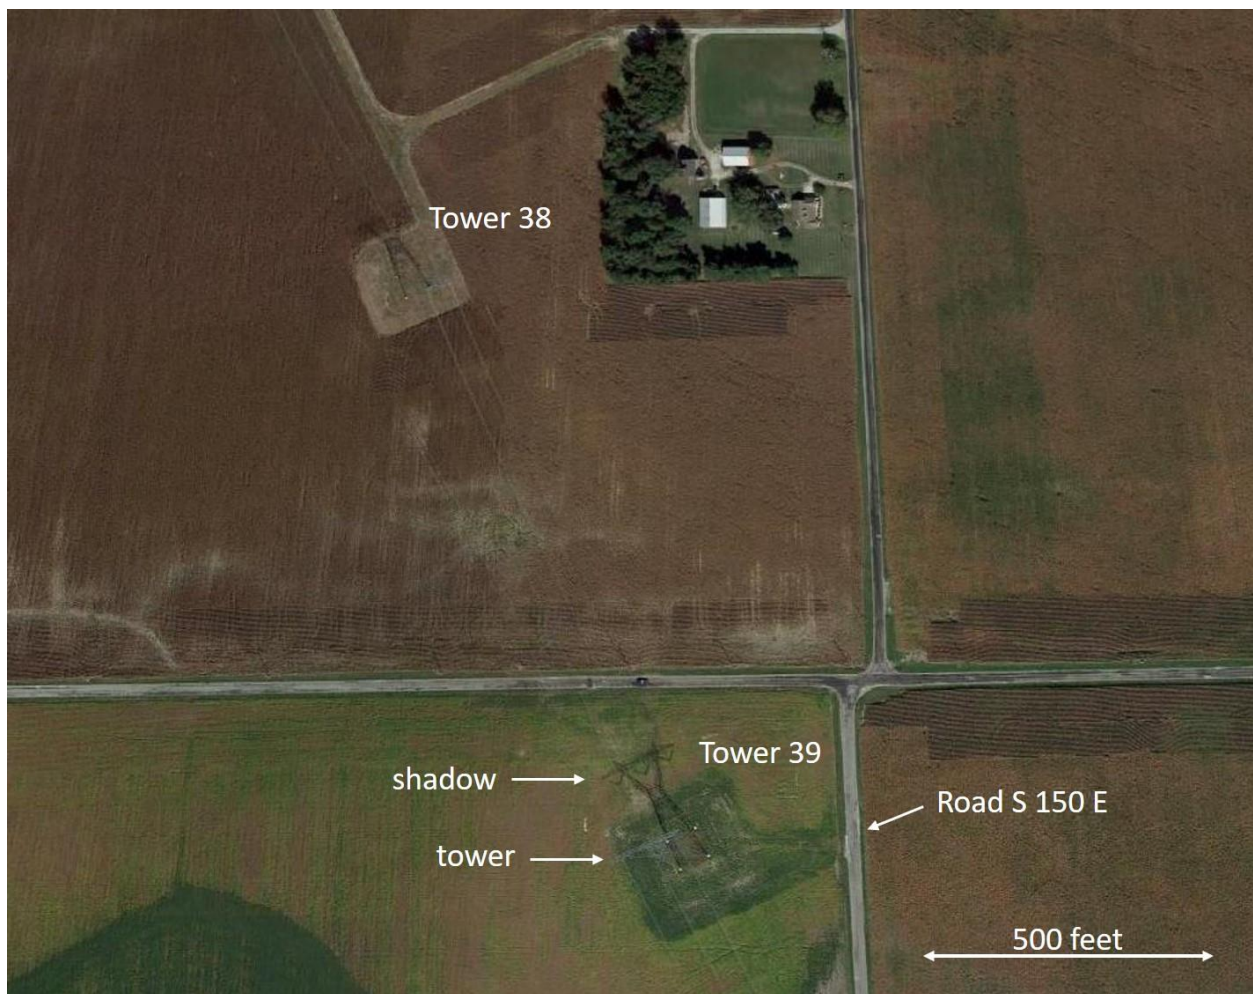
Figure 1. Aerial View of the Accident Area

Figure 1 shows an aerial view of the accident area. It shows Tower 39, near which the helicopter crashed when threading the sock line through it, and Tower 38, that was already threaded. The sock line extended from Tower 38 to the helicopter that was near Tower 39 and was pulling the sock line. The dimensions of the towers were known and were used for calibrating the camera.

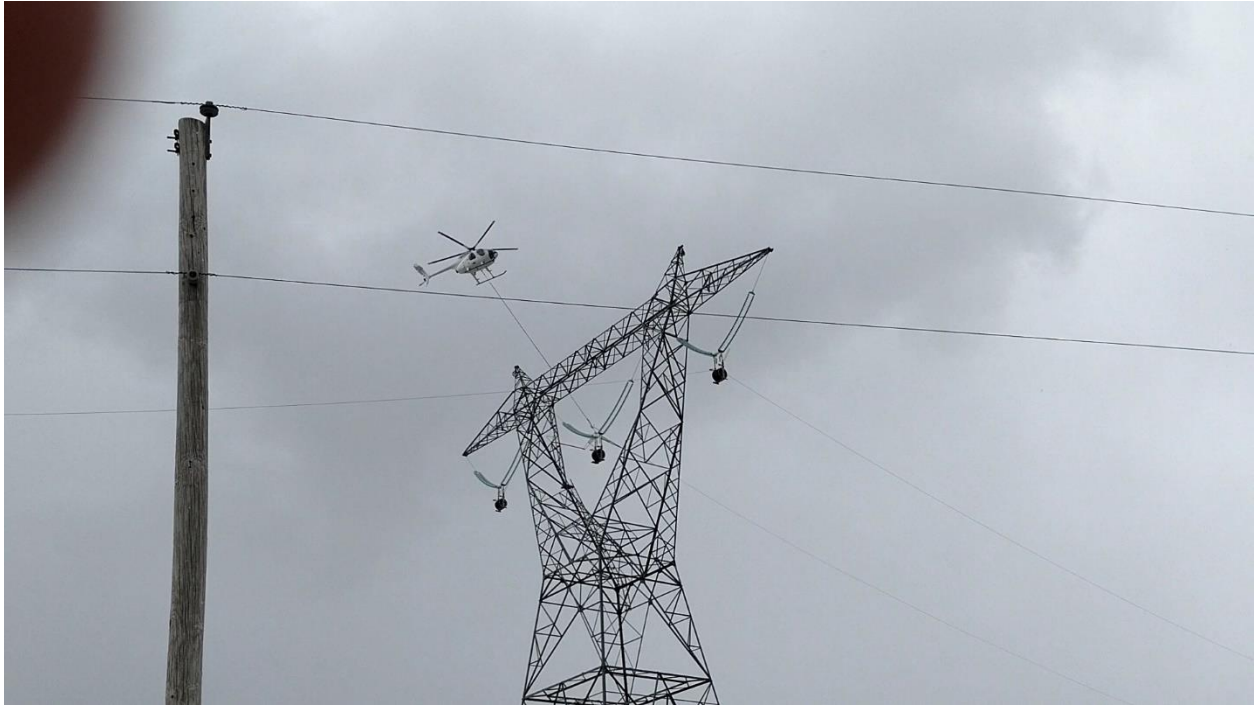
Figure 3. Video Frame No. 5210 (T=-2.5 seconds)

Frame 5210, shown in Figure 3, was acquired at time -2.5 seconds, 2.5 seconds before Frame 5285 was acquired. It was analyzed to illustrate the situation before the events resulting in the crash started at time 0.0 seconds.

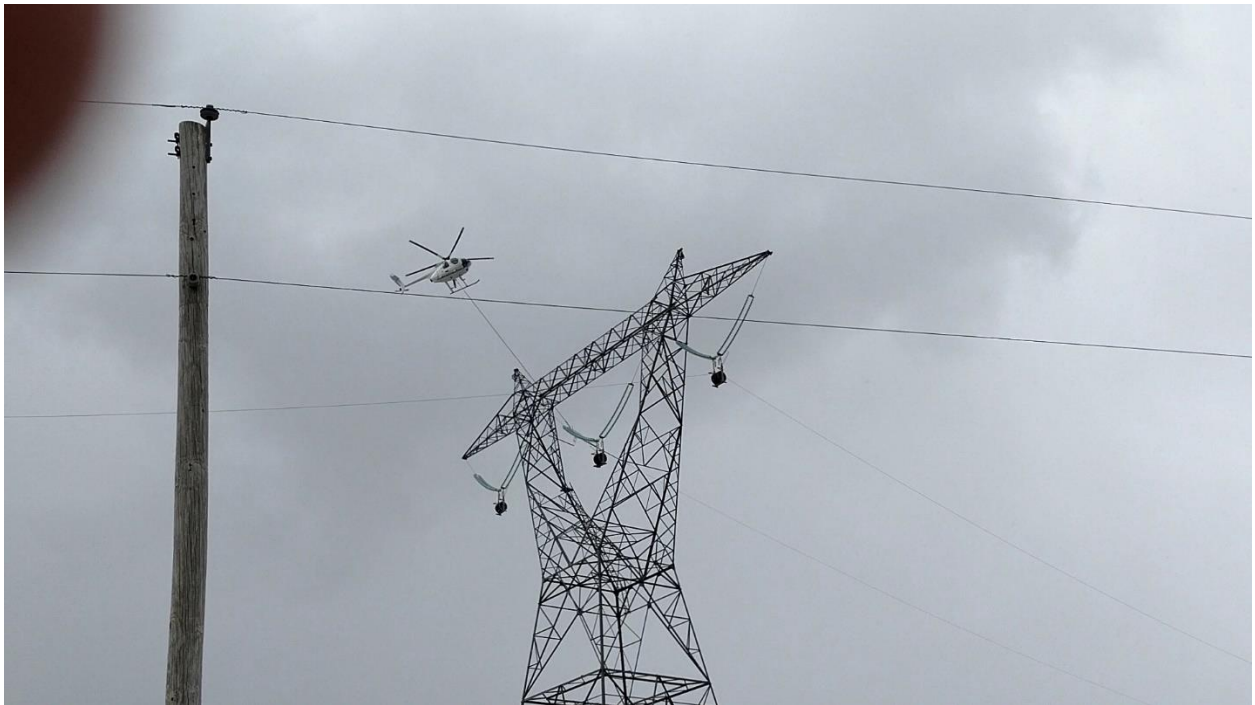
Figure 4. Video Frame No. 5249 (T=-1.2 seconds)

Frame 5249 is shown in Figure 4. It was acquired at time $T=-1.2$ seconds, approximately when the leading end of the needle contacted the tower for the first time. The force that the long line applied on the helicopter at that time was still primarily due to the weight of the sock line.

The video shows that shortly before time $T=-1.2$ seconds (see Figure 4), when the needle first contacted the tower, the helicopter started moving backward. Figures 10 and 11 show that the helicopter yaw angle was about 45° with respect to the tower at that time. It is possible that the pilot decided to move backward assuming it would move the needle away from the tower. However, that strategy did not work as expected. Figure 2 shows that in normal operation, the needle is oriented vertically. Figure 4 shows that as the helicopter moved backward, the needle rotated (rolled) and was no longer oriented vertically. The rotation moved the leading edge of the needle closer to the tower rather than away from it and at time $T=-1.2$ seconds it contacted the tower. Further backward movement then pulled the hook near the center of the needle into contact with the tower and it led to tethering of the helicopter to the tower.

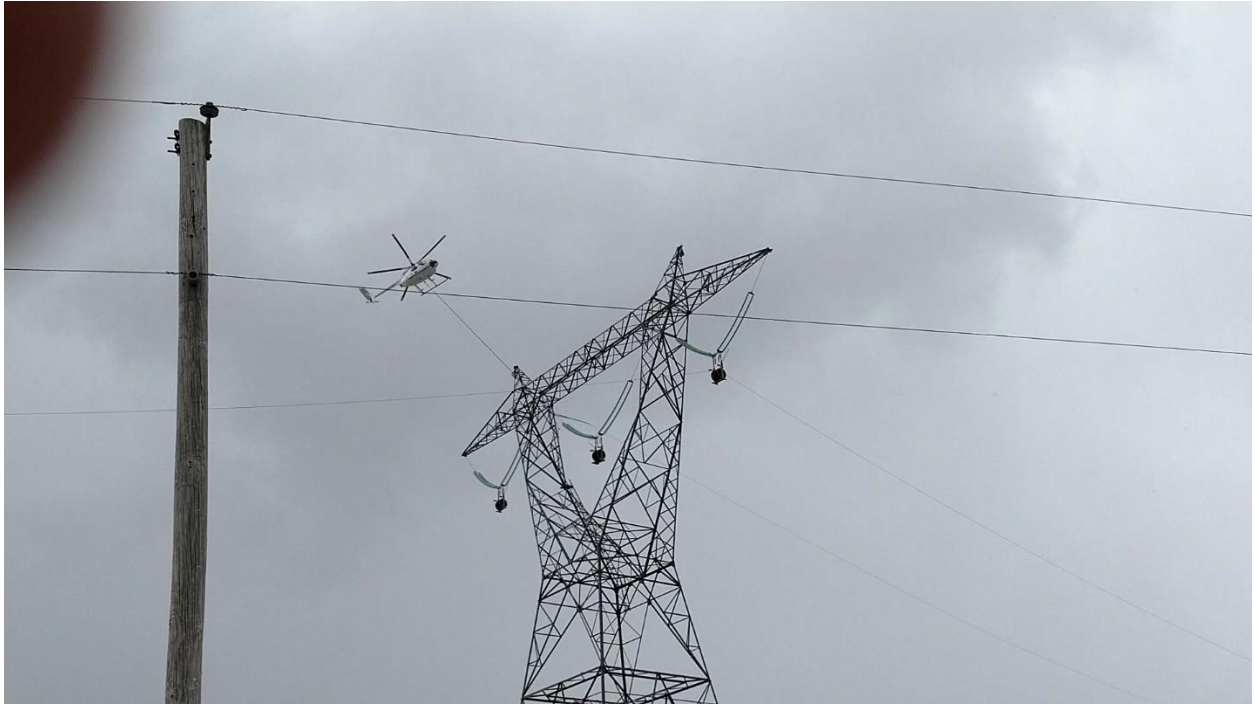
Figure 5. Video Frame No. 5285 (T=0.0 seconds)

Frame 5285, shown in Figure 5, was acquired at time $T=0.0$ seconds. It shows the helicopter at the approximate time when the forces applied on it by the long line are about to transition from being due to the weight of the sock line to being caused by the entanglement of the needle with the tower. It is considered the beginning of the events that resulted in the crash.

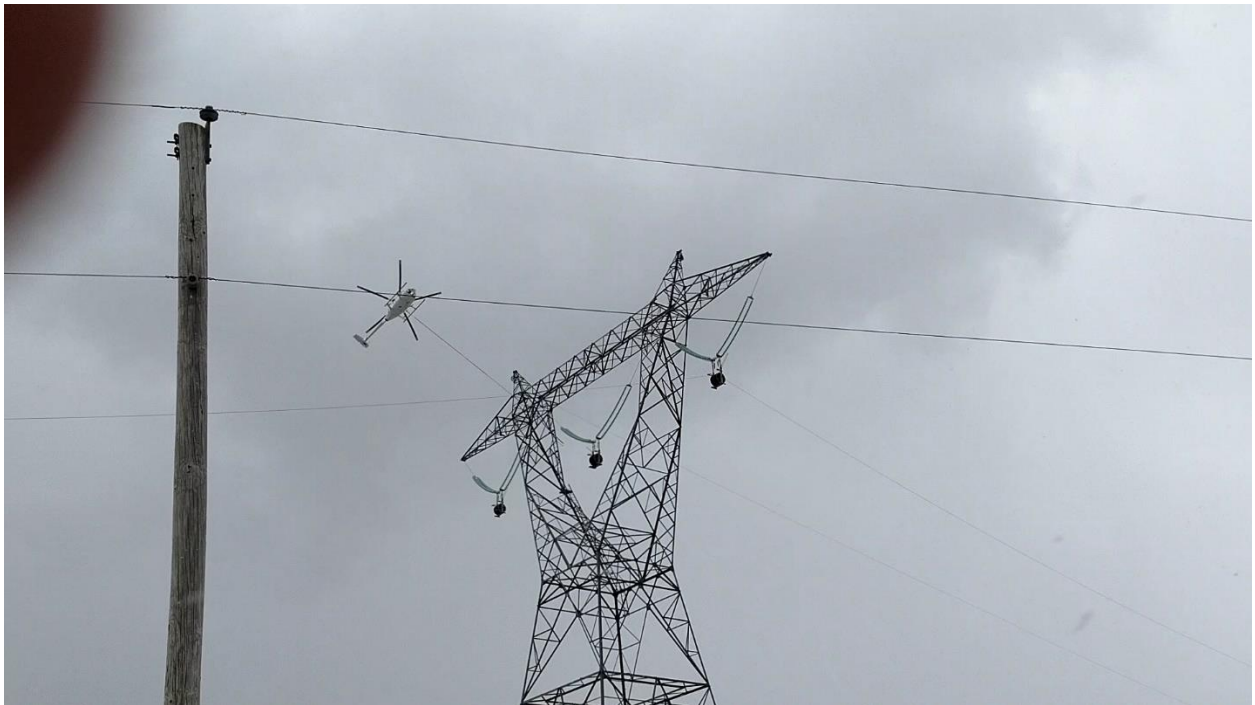
Figure 6. Video Frame No. 5310 (T=0.83 seconds)

Frame 5310, shown in Figure 6, was acquired at time $T=0.83$ seconds. It displays the helicopter right after the hook near the center of the needle became entangled in the tower. It is possible that the hook at the front of the needle was also entangled at this time. It cannot be determined from the video whether one or both hooks were entangled. The entanglement changed the forces that the long line applied on the helicopter. The helicopter became tethered to the tower and its distance from the entangled hook near the center of the needle was fixed to the length of the long line. The force that the long line applied on the helicopter was primarily the reaction to the helicopter rotor thrust.

It is believed that the situation was not recoverable past time $T=0.83$ seconds. One second later, at time $T=1.83$ seconds, the video shows the helicopter in a loss of control situation and descending toward ground impact. It impacted the ground at time $T=7.5$ seconds.

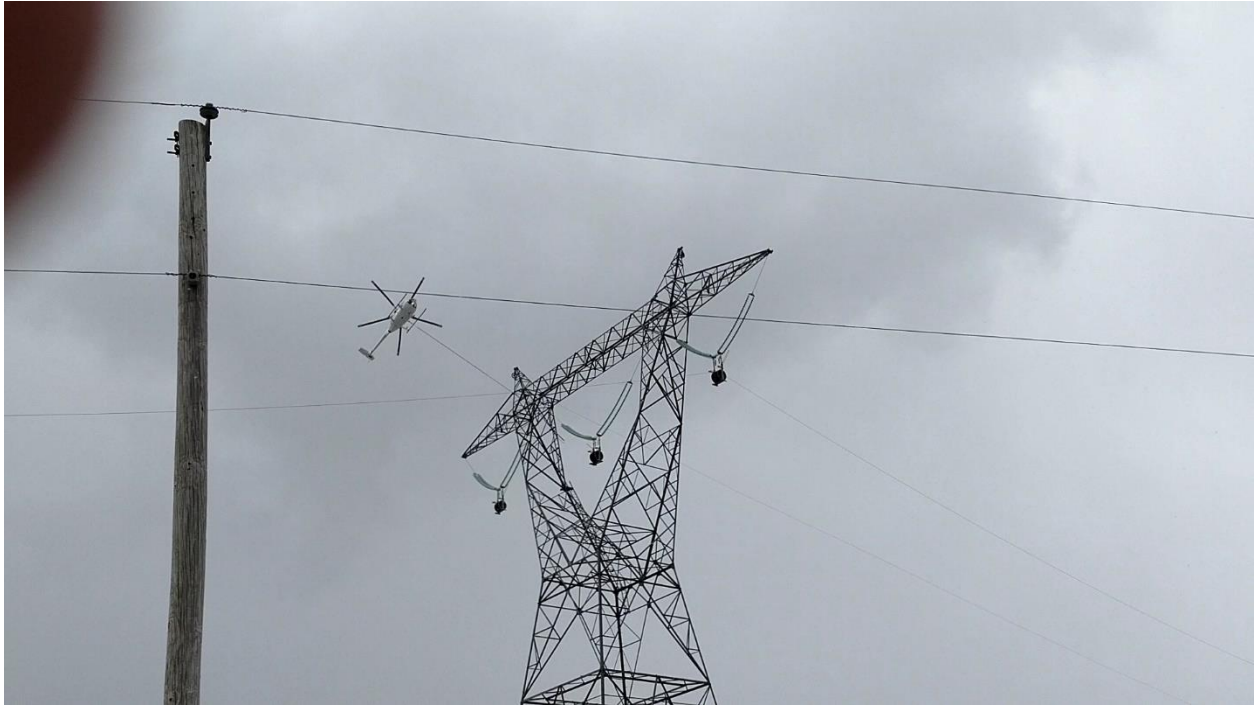
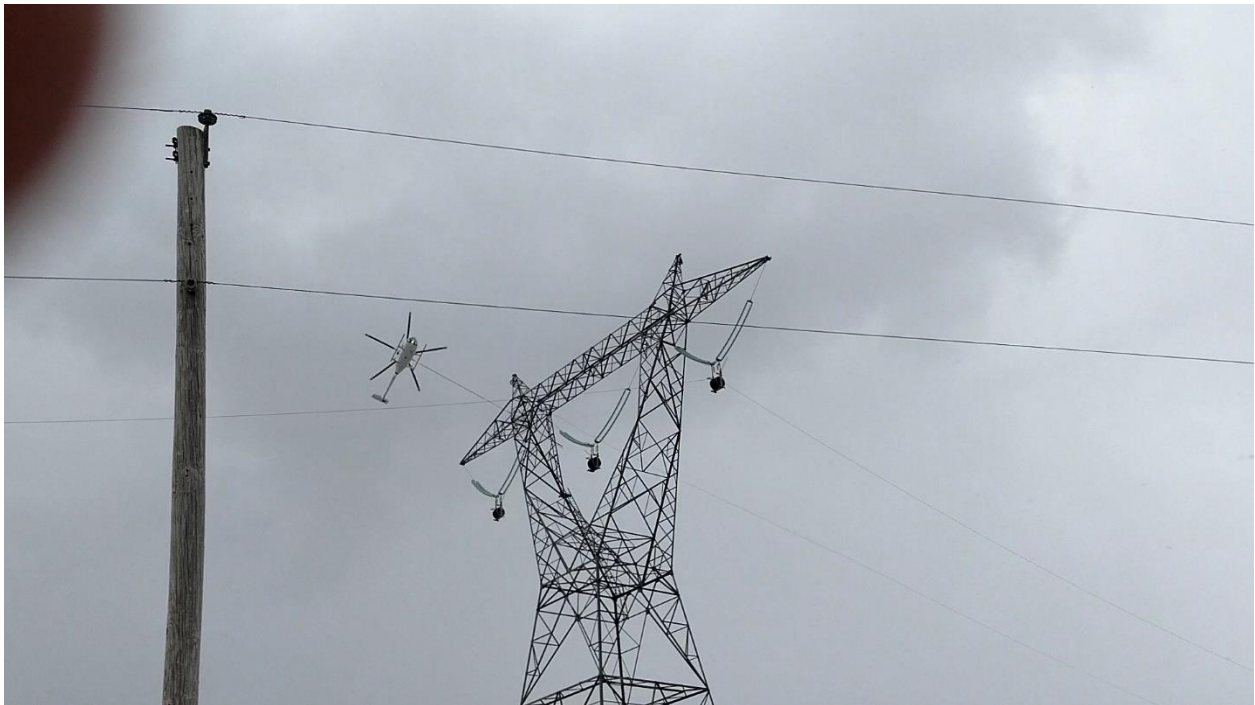
Frame 5315, acquired at time $T=1.0$ seconds and Frame 5325, acquired at time $T=1.33$ seconds, are shown in Figure 7 and Figure 8, respectively. They show the helicopter past the time of no recovery, tethered to the tower. The hook near the center of the needle fractured and separated from the needle at approximately time $T=1.33$ seconds.

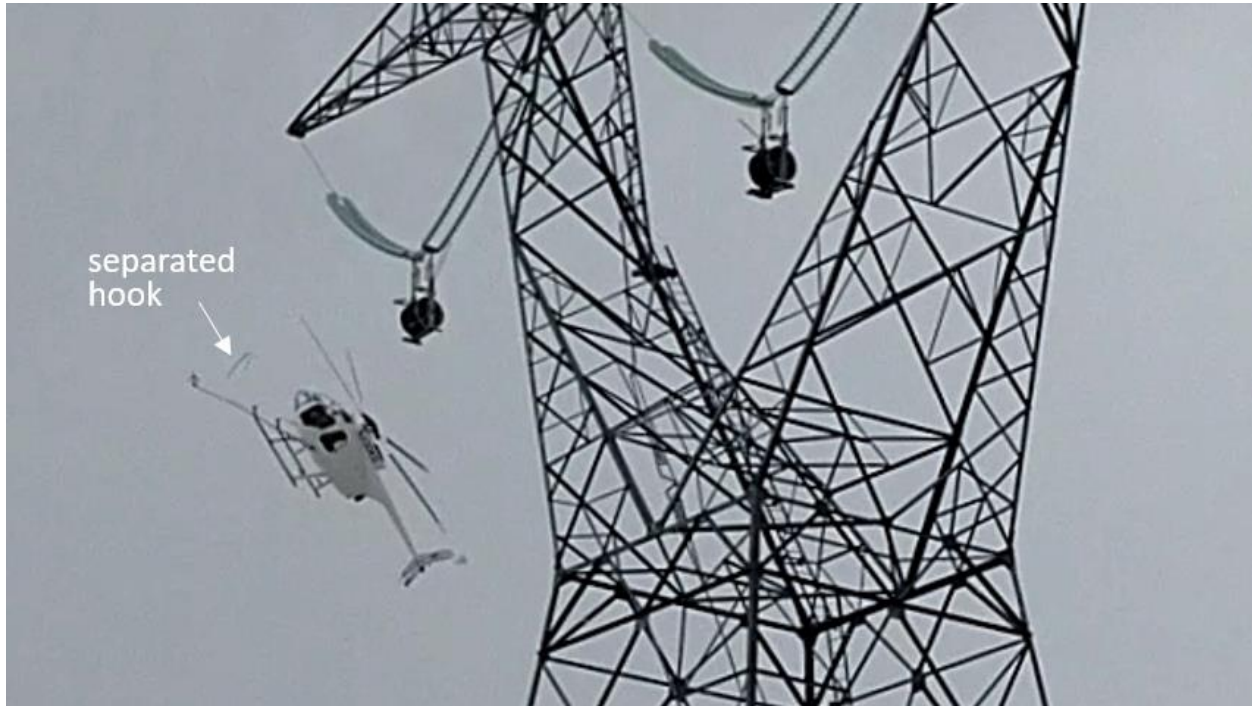
Figure 9. Detail from Video Frame No. 5373 (T=2.93 seconds)

Figure 9 shows a detail from Frame 5373, acquired at time $T=2.93$ seconds. The hook that was attached near the center of the needle is visible separated from the needle and from the grappling hook at the end of the long line.
